St Andrews/ Rosedale Terrace Distribution System

Waterworks # 260001250
System Category – Large Municipal Residential

Annual Water Report

Prepared For: Township of South Stormont

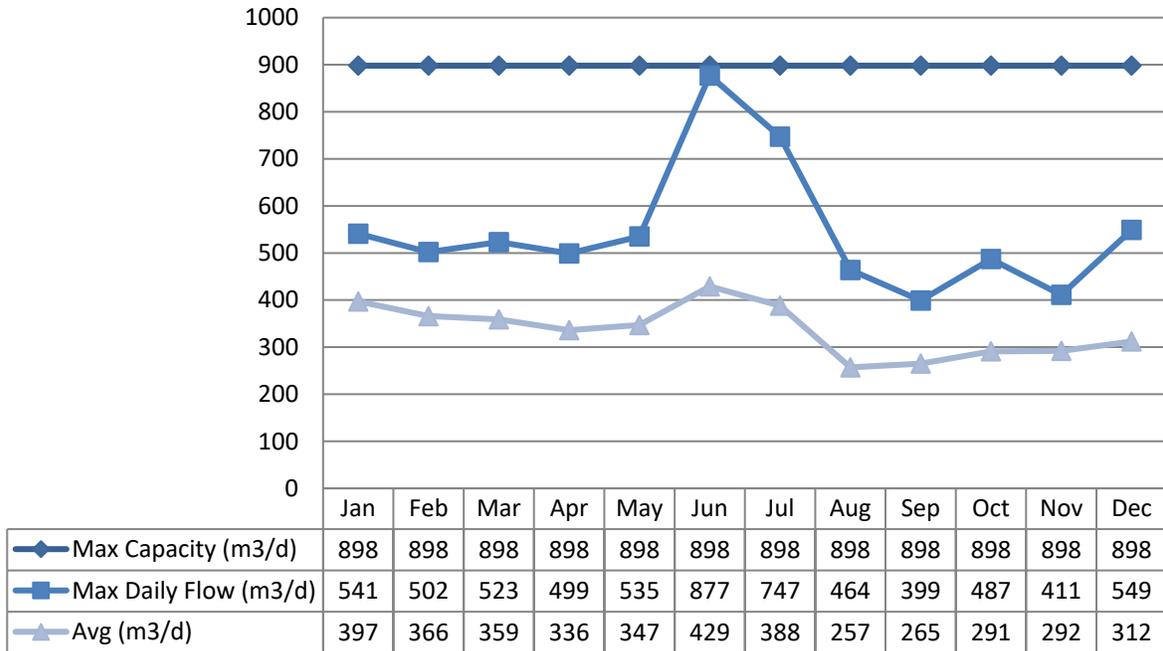
Treated Flows

Treated Water Flows

The Treated Water flows are regulated under the Municipal Licence.

Rated Capacity - MDWL
